REPORT OF THE 2020 EXCAVATIONS
AT MACHKHOMERI
(KHOBİ MUNICIPALITY)

by Revaz Papuashvili, Georgian National Museum

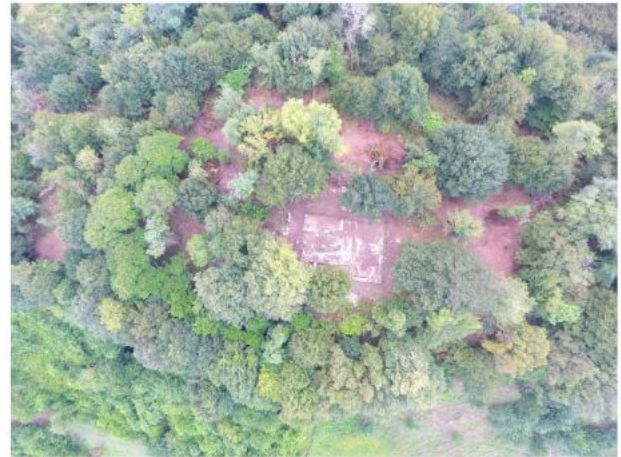
Fig. 1. Drone photograph of the site seen from the north (D. Naskidashvili)

Machkhomeri is a hilltop site situated 100 metres above sea level and 3.5km to the northwest of Khobi, western Georgia (Fig. 1). Before the current excavations, the site had been surveyed by Nikoloz Murghulia, who provided a useful preliminary plan of the site and advanced a late antique chronology in 2010.¹ Excavations at the site commenced in 2018 with several trenches to test the potential of the site for future work and identify its main structural components.² It was clear by then that the site consisted of a fortified wall surrounding a large building, the function of which remained unknown until 2019. That year, more extensive excavations targeted the remains of this building, which revealed a church. The

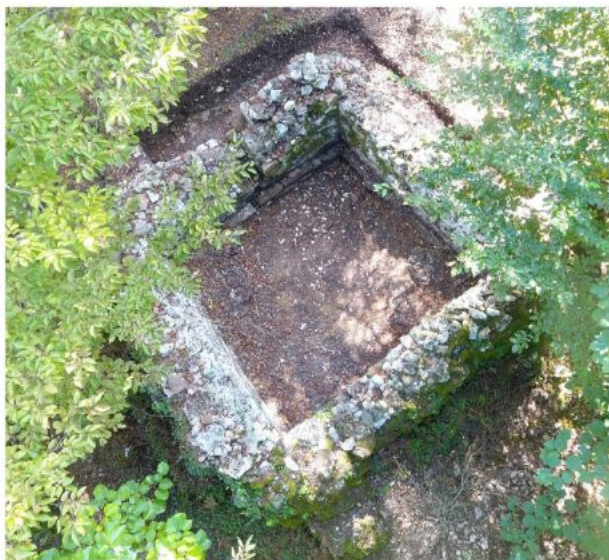
Fig. 3. The northwest tower seen from the northwest (D. Naskidashvili)

The tower is situated 21.5m to the northwest of the church (Fig. 3). The excavation aimed to clear the high vegetation cover from the structure, unearth its walls, and excavate its fill. The building is a 6 × 6m square; its walls are 0.8 to 1.0m thick and extend for up to 3 metres. No evidence of an entrance has been found. The building must have been frequented in modern times, perhaps for use as a temporary shelter, as suggested by modern artefacts recovered during the excavation of its fill. The modern frequentation and vegetation cover resulted in disturbances of the strati-

graphy inside the building. During the excavation of the fill, no significant diagnostic artefacts have been identified.

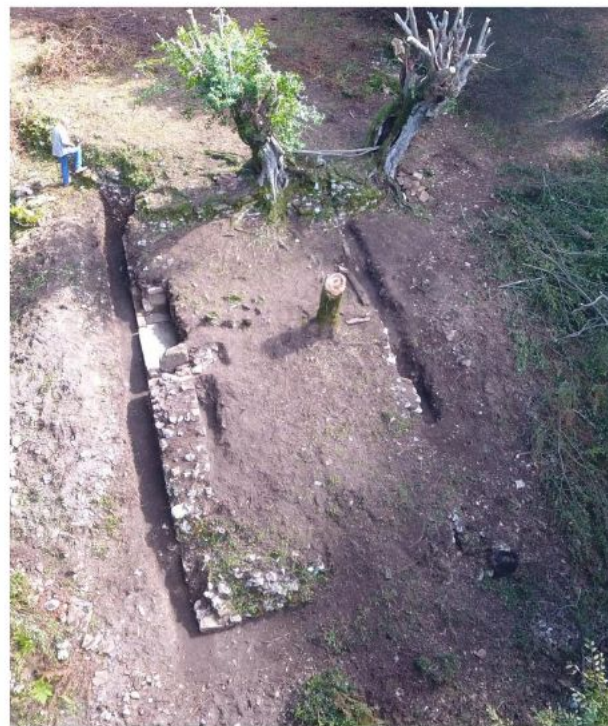
Fig. 4. The southwest building seen from the south (D. Naskidashvili)

The second structure associated with the fortifications at Machkhomeri is located 23m southwest of the first (Fig. 4). Although this structure has preliminarily been identified as a tower, its function is not yet fully understood given the incomplete state of the excavation in this sector of the site. The feature is situated on a steep slope and, at the time of the excavation, it was scarcely visible, entirely covered by soil, bushes, and trees. Because of this obstruction and due to time constraints, this year's excavation aimed to clarify the size of the feature. This result was achieved by excavating a 0.5m-deep trench alongside the course of the walls. The vegetation cover inside the structure was also cleared, but its fill was not excavated. The structure is 9.1m × 5m, and its walls are approximately 0.8m thick. The walls extend for up to 2m in the northern part of the structure, while the walls are at a lower height in the rest of the building.

The excavation revealed a large, 1.6m-long block placed horizontally and flanked by vertically-placed stone blocks. The block may be a threshold. Given that the threshold opens westward, thence outside the area delimited by the fortifications, it is reasonable to conclude that this structure allowed access to the site. The excavation of the fill of the structure, which is planned for 2021, will clarify the function of the building and, hopefully, its chronology.
